PROPERTY INSPECTION REPORT

Concerning: Any Where - Grand Prairie, Texas 75054
(Address or Other Identification of Inspected Property)

By: Lance Lambert TREC Lic #9208 03.18.08
(Name and License Number of Inspector) (Date)

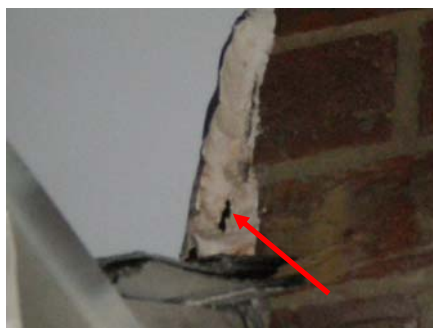
- The roofs flashing is lifting and/or pulling loose on the east side of the house (above the rear porch) and should be re-secured and re-caulked to avoid leaks.

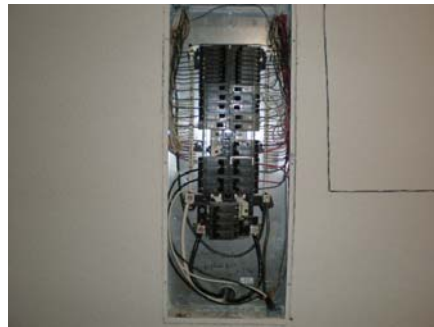
Panel Box: *Main Panel Breaker Box(es) (200 Amp Rating) with main disconnect is located at the Garage Interior.*
